Iron nails recovered from the plank of the Shinan shipwreck

Abstract

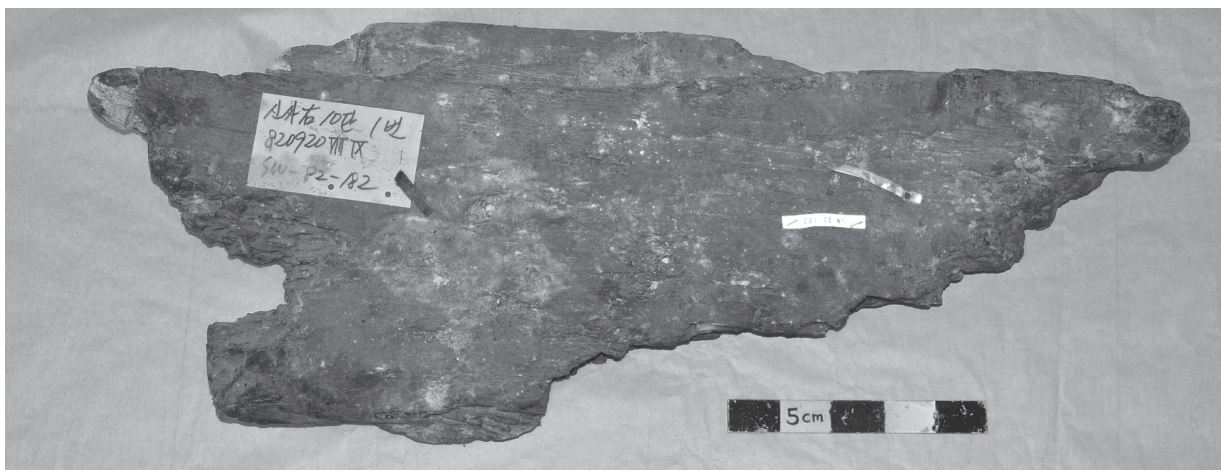
Figure 4.1 Hull plank (SW-82-182) from the Shinan shipwreck. (Photo by Jun Kimura)

SW-82-182 is a portion of a hull plank from the Shinan shipwreck (Figure 4.1). Due to deterioration, the only remaining original dimension is the thickness of the plank (105 mm). Present dimensions are a maximum width of 395 mm and a maximum length of 1.02 m. The original placement of SW-82-182 is yet to be determined clearly. The rabbet, however, appears to be cut at only one seam that likely joins to the edge of the lower plank (Figure 4.2). Most parts of the hull planking of the Shinan shipwreck are

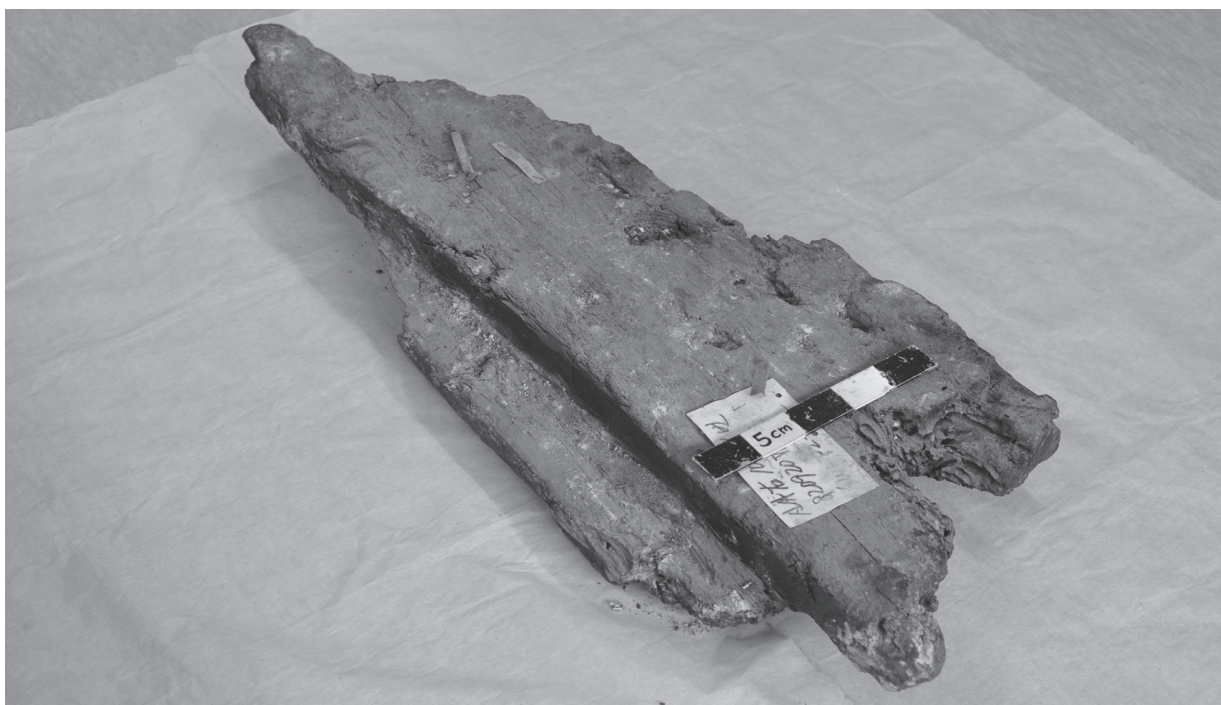
Figure 4.2 Rabbeted seam of the SW-82-182, and a scale is placed on the inner surface of the hull plank. (Photo by Jun Kimura)

rabbeted clinker construction, except for the planking in the bow, forward of the first bulkhead shows gradual changes from clinker to carvel. The feature identified with the plank (the rabbet cuts at only one seam) must have been used in the clinker-built part. It appears that a few corroded nails are driven from outside of the rabbeted seam. The pattern indicates that the plank was located at the portside.

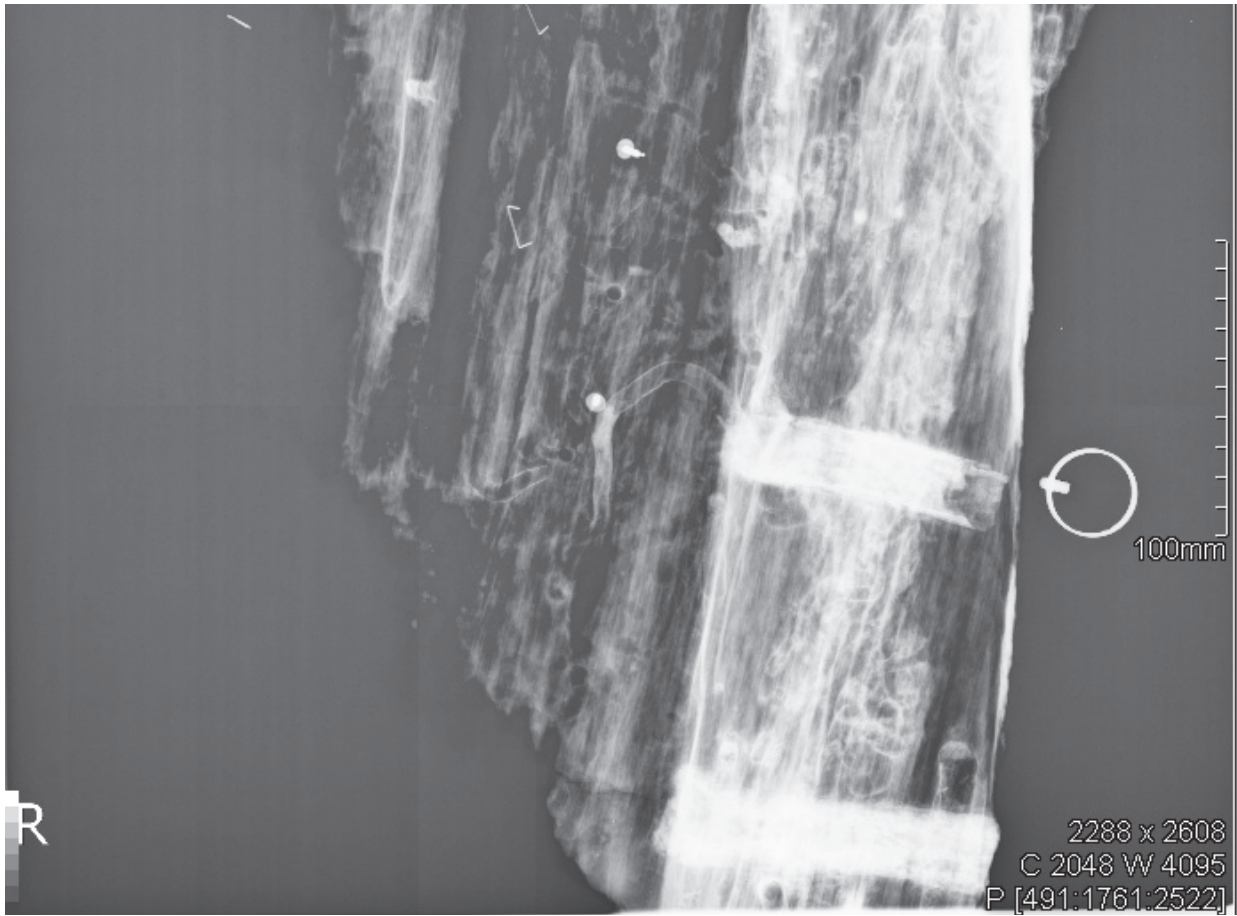
The x-ray and CT-scan images show that broken remains of four nail shafts are diagonally driven at the rabbeted seam (Figures 4.3 and 4.4). The interval of the four nail shafts shows slight irregularity. Two spaces between three of the nails measure 250 mm. The other two nails were very narrowly spaced at about 80 mm. Nail length ranges from 95 to 145 mm.

Figure 4.3 X-ray image of the SW-82-182 showing the two iron nails that have square cross-sections. (Courtesy of the National Research Centre of Marine Cultural Heritage)

From the analyses, the quality of the iron remains seems to be different. The x-ray and CT-scan images present a fully-corroded iron remain that is shown as a black hollow image with a only thin magnetite layer that indicates the presence of the original

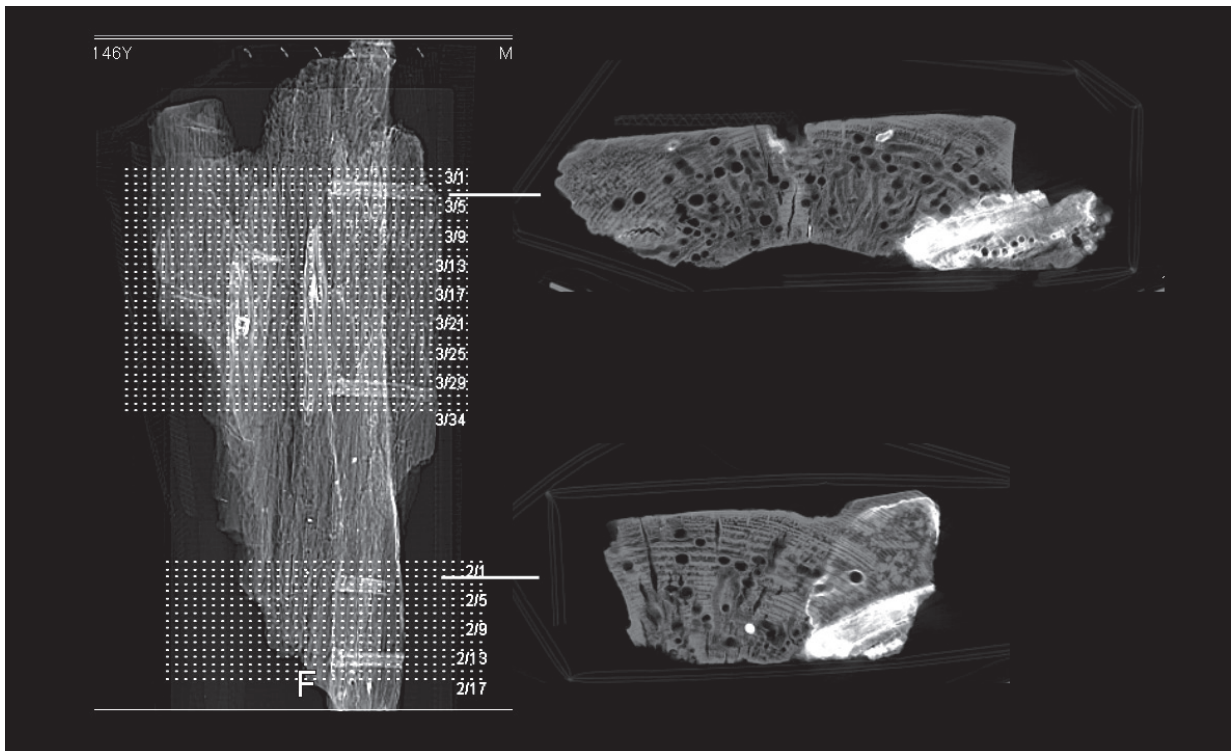
Figure 4.4 CT-scan image of the SW-82-182 and images of the cross-sections where the iron nails are driven. (Courtesy of the National Research Centre of Marine Cultural Heritage)

The nail shaft is slightly skewed and tapered (as seen in the CT-scan image Figure 4.4). The configuration of the nail shaft remaining at this seam evidences that original nails were skewed nails. From the remains of the nail shafts at both the upper and the lower seams, the original length could reach 250 mm but is less likely to have exceeded 300 mm. The cross-section of these nails measures a square 20 mm on each side and the section of one of the nails is exposed on the broken part of the lateral of the plank.

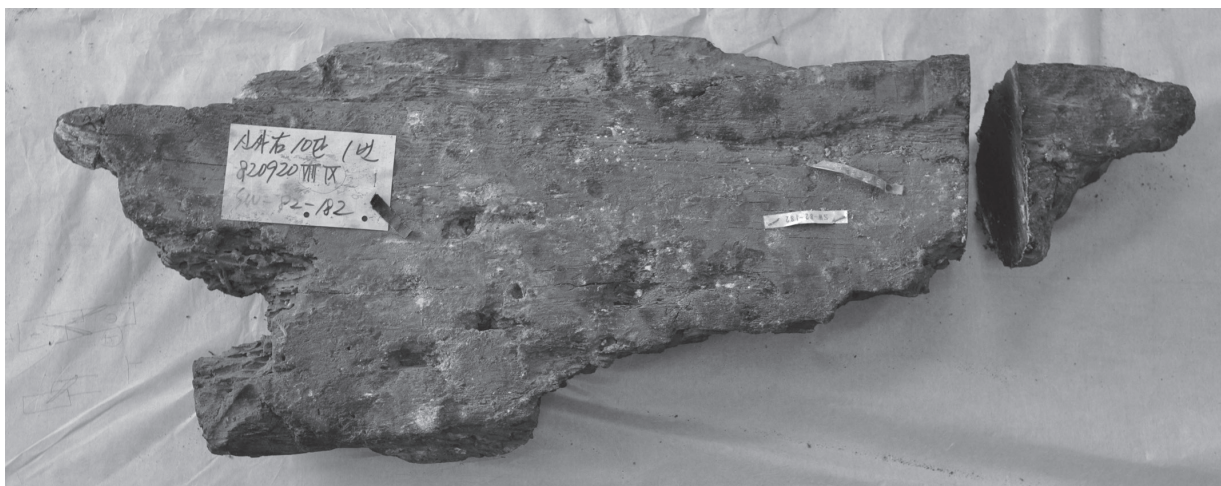
Figure 4.5 A cut piece from the SW-82-182 for metallographic analysis. (Photo by Jun Kimura)

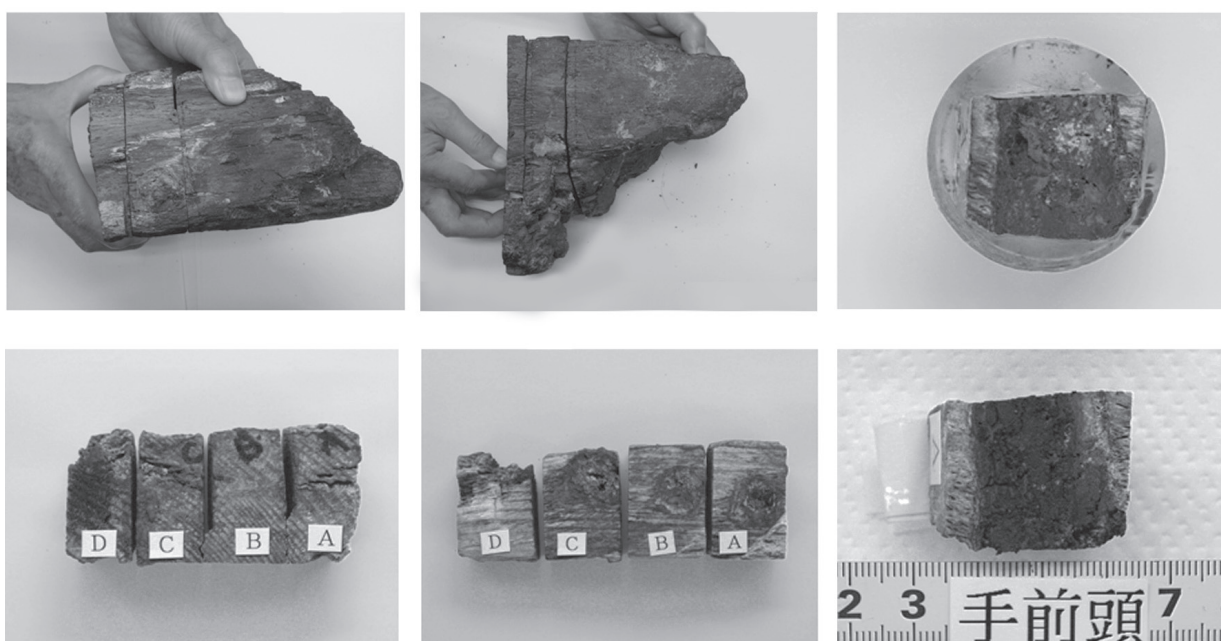
Figure 4.6 Specimens containing a nail remain from the cut piece. (Courtesy of the Kyushu Techno Research Inc)

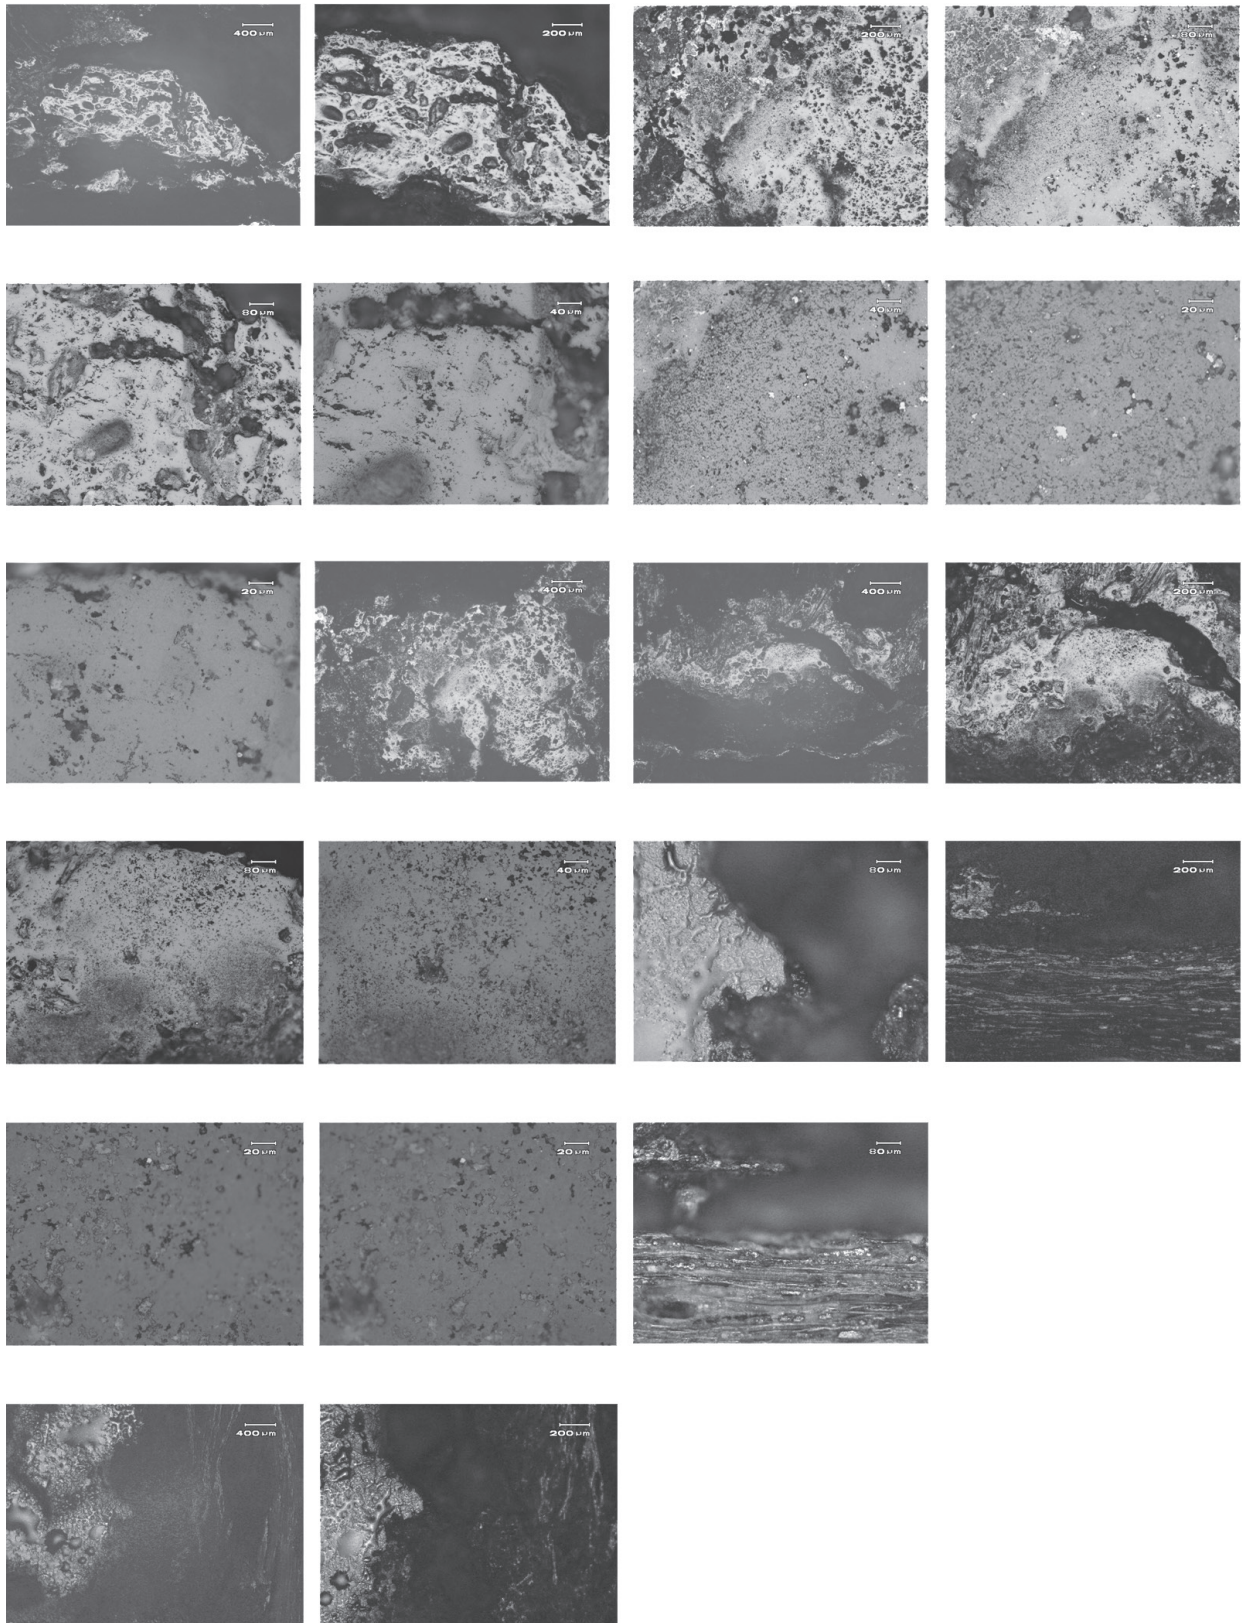
Figure 4.7 Microscopic images of the structure of the nail remain. (Courtesy of the Kyushu Techno Research Inc)

has been fully oxidised and the nail does not contain metal structures. The corrosion status of the nail is hydrated iron oxide (goethite: Fe₂O₃/H₂O). The substantial oxidization caused the loss of the metal structure. Under this condition, it is difficult to assess the quality of the original iron.
